First Choice
Home and Termite Inspections

PROPERTY INSPECTION REPORT

Report #: SAT20110225-01

Concerning: 11555 Sample, Helotes, TX 78023
(Address of Inspected Property)

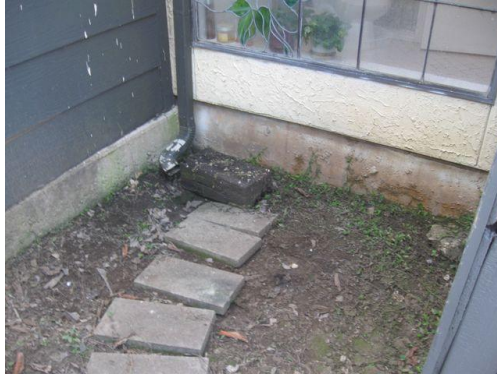
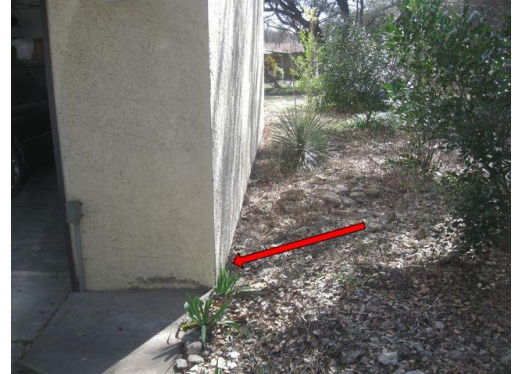
1. The yard does not adequately slope away from the foundation wall at all sides of the house. Water puddling in low areas against the foundation wall can cause damage to the foundation.

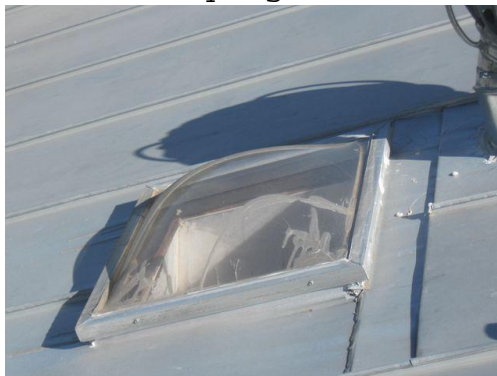
1. Cracked skylight covers.

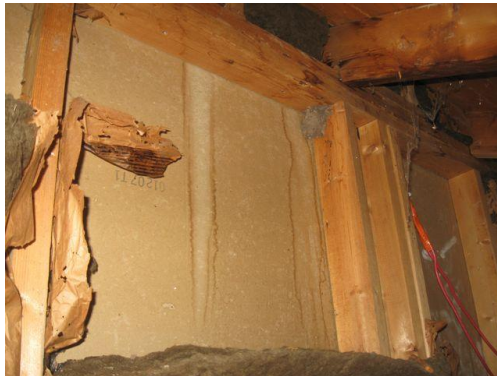
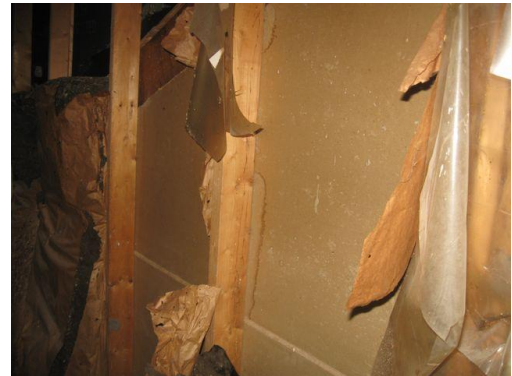
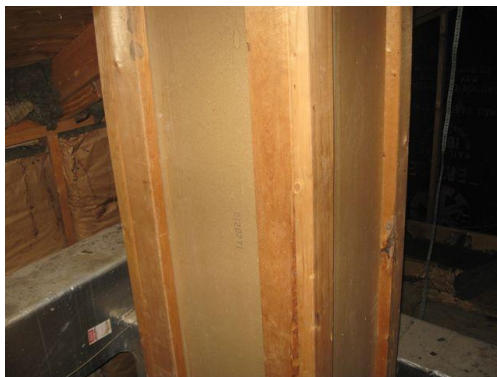
1. The insulation is most likely original and has become compact over the years. The insulation is not as effective in this condition as it was the day it was installed. Additional insulation may be needed.
2. Insulation has fallen out of place at several areas of the attic.

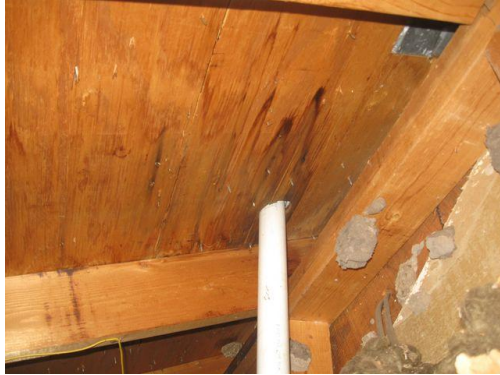
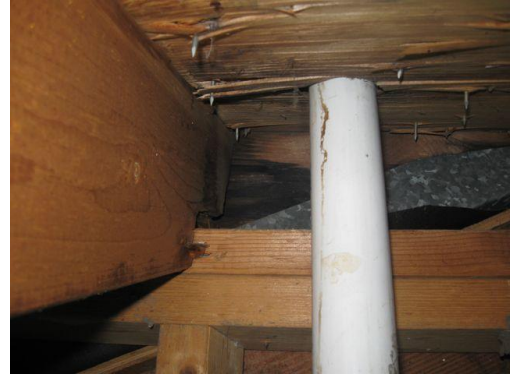
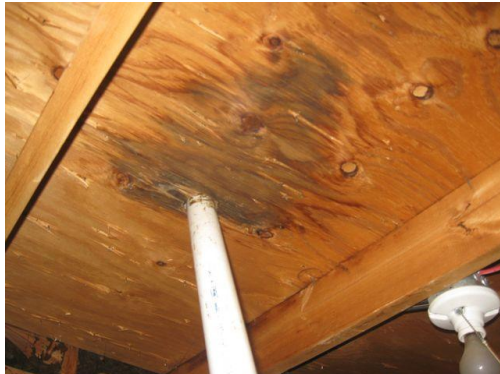
3. Several areas of water penetration observed in the attic. Around vent penetrations, around wall-to-roof transitions, at skylights, etc..

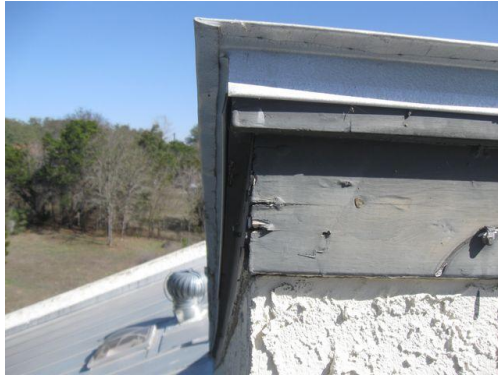
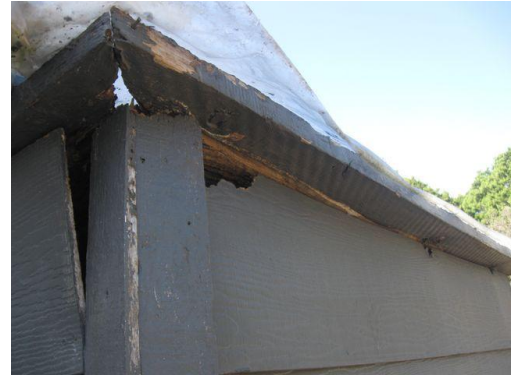
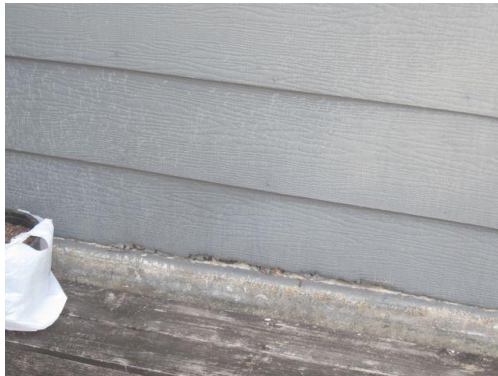
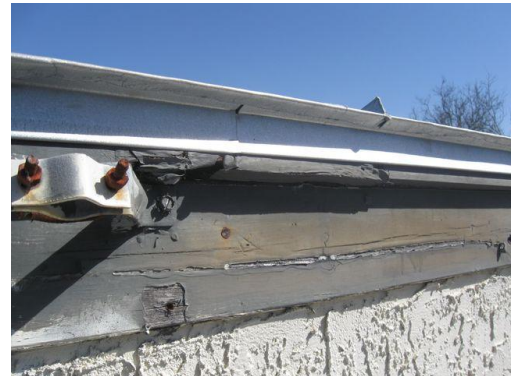
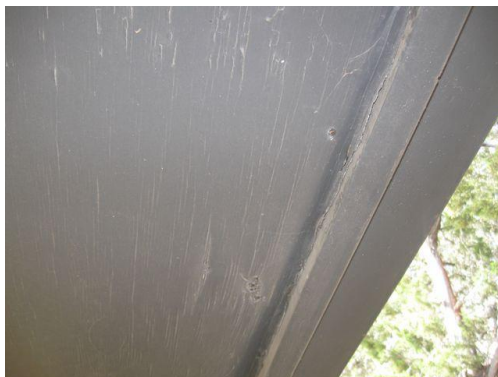
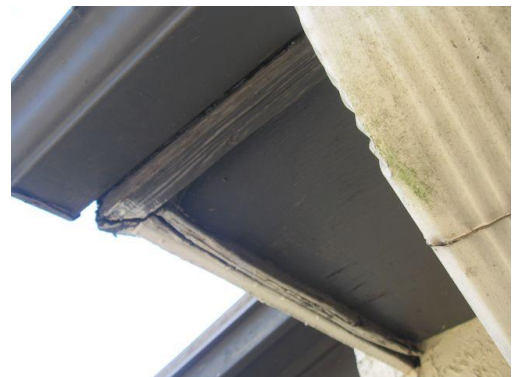
3. There are several scattered areas of wood rot on the exterior of the house.

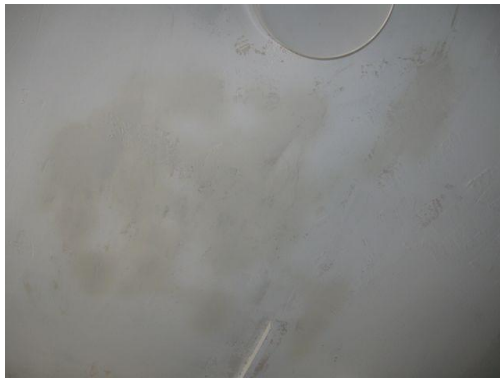
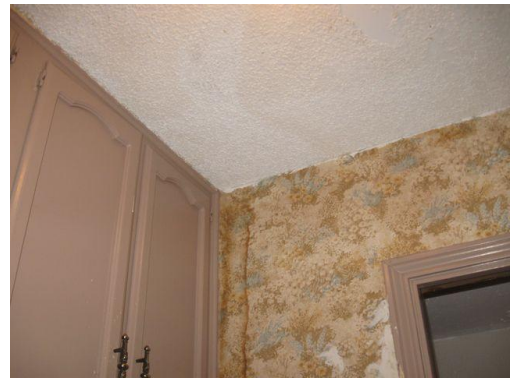
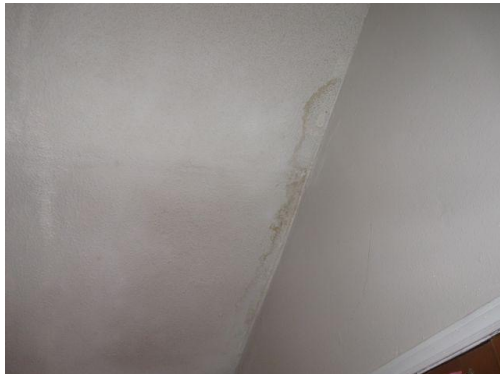
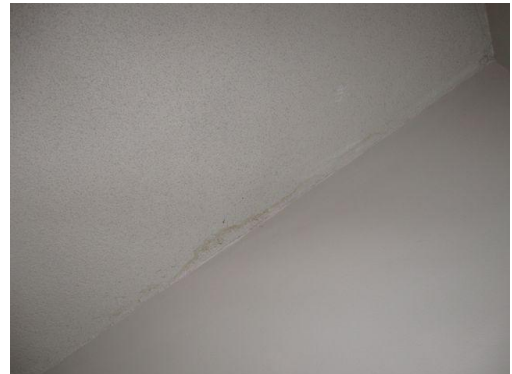
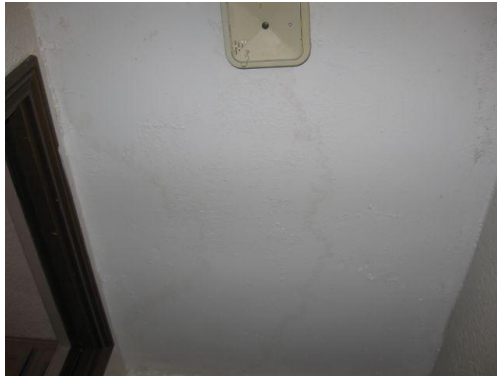
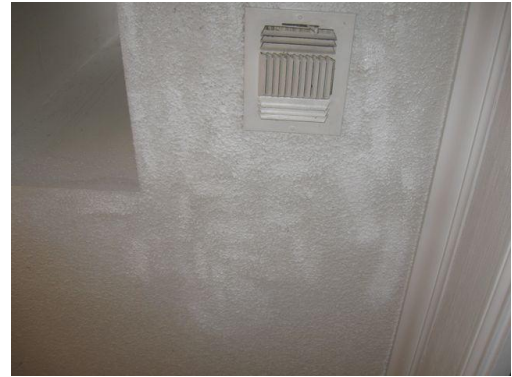
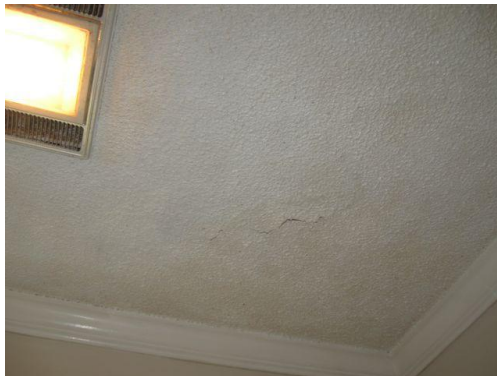
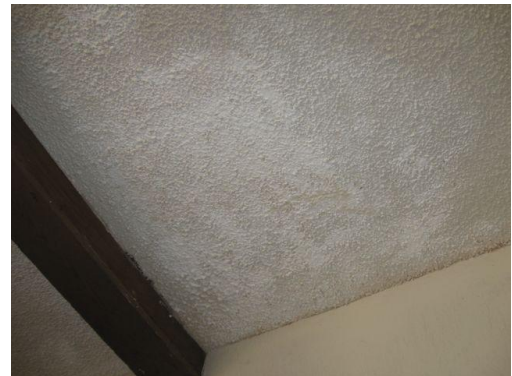
1. There is miscellaneous damage to the garage ceiling.
2. There are several areas of patches/repairs. The client is advised to refer to the sellers disclosure document for information regarding previous repair history.
3. There are water stains on
 - ceiling of the laundry room,
 - master bedroom,
 - hallway near the master bedroom,
 - master bathroom,
 - garage,
 - skylights upstairs and down,
 - formal dining room,
 - guest bathroom ceiling on the right side of the house.

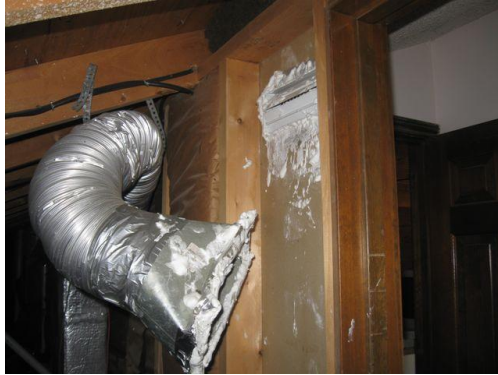
1. Poor installation of ducting for the upstairs portion of the house. The ducting has pulled loose and has very little air flow.

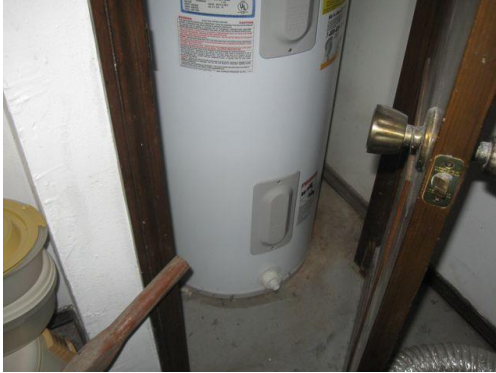
1. The unit is in the garage and is not elevated 18 inches off of the ground.

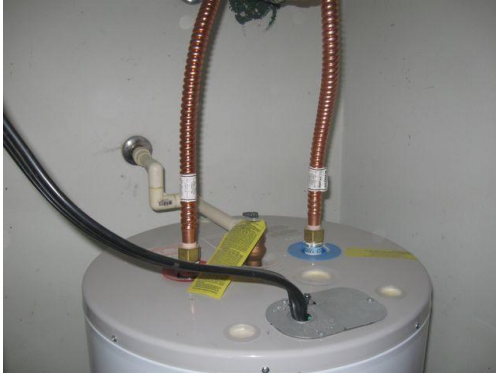
2. The T&P drain line does not have a gravity flow to it. (should point downwards to drain off any small leakage that should occur.)
